# Ultimate Professional Smart Acoustic Inspection

**FOTRIC H7**  
Acoustic Imaging Cameras

# NaviPdM<sup>®</sup> Venus Smart Inspection Assistant

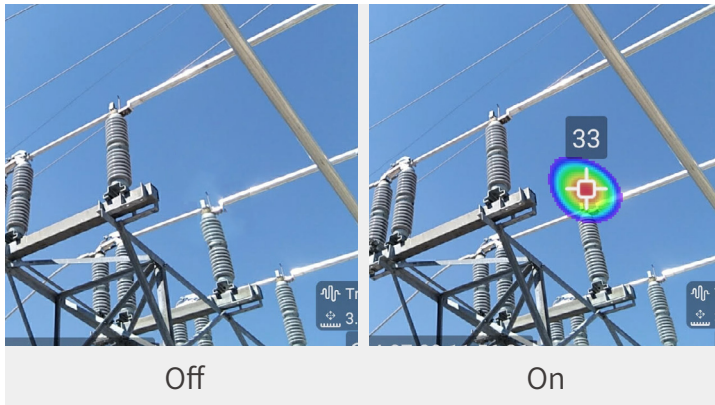
### Acoustic Image Delay (T-FFTD®)

Utilizes a multi-modal transient acoustic matrix to enhance microsecond-level acoustic event retention.

Boost signal retention and enhance inspection efficiency for intermittent sound sources.

| T-FFTD® | Capture instantaneous sound signals and make it stay longer in real-time acoustic display. |
