# Ultimate Professional Smart Acoustic Inspection

**FOTRIC H7**  
Acoustic Imaging Cameras

# NaviPdM<sup>®</sup> Venus Smart Inspection Assistant

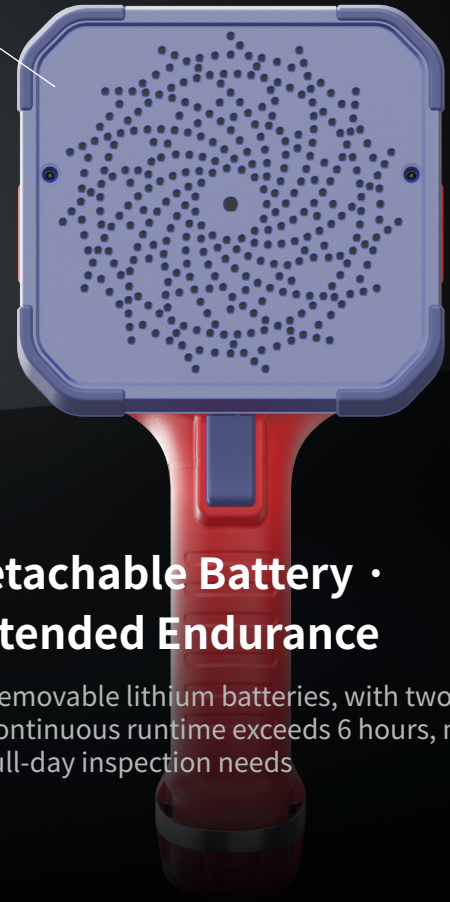
## Ultra-Compact Microphone Array

- Spiral topology-optimized array with 345 MEMS digital microphones
- Ultra-high channel count enables wider sound field coverage and finer acoustic mapping, greatly improving inspection efficiency and diagnostic accuracy
- Ultra-long listening range: operational distance from 0.3m to 300m
- Lightweight yet rugged ergonomic design ensures comfortable grip and easy portability

| Microphone Channels | 345 MEMS digital microphone |
| Working Distance | 0.3~300m(1~984ft) |

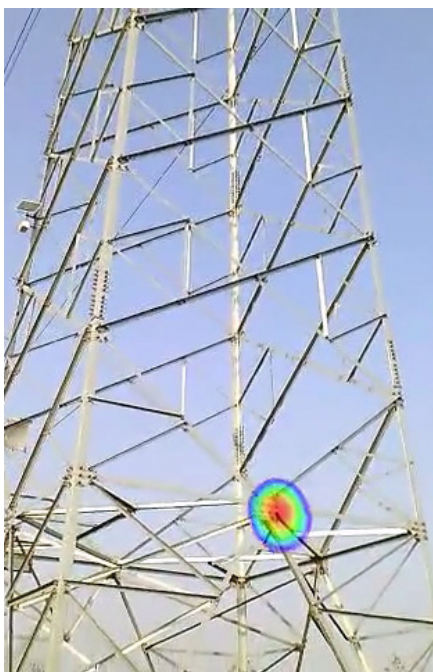
Loosen Bolt

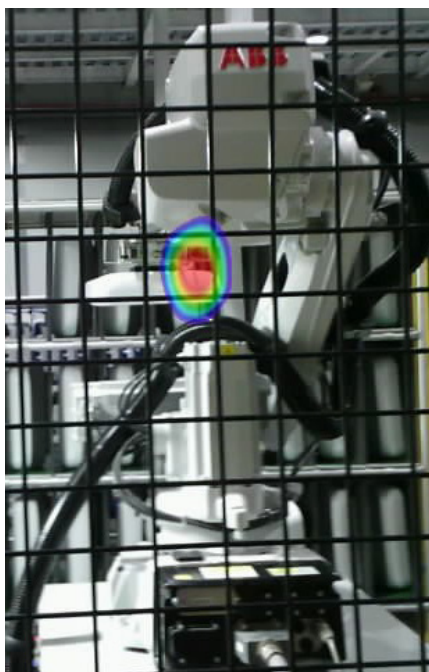
Mechanical Damage

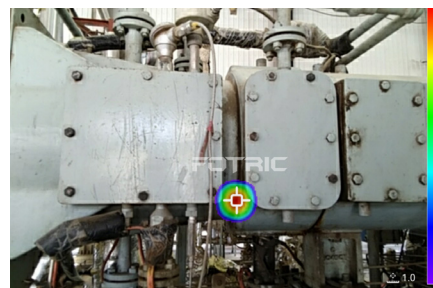
Vacuum Leak

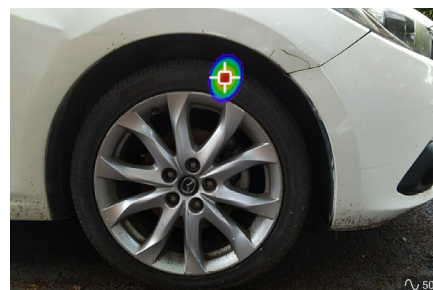
Leaky Tire
